Common Artifacts and Analysis in CT Equipment

Qionghui Cai

The Second Affiliated Hospital of Wenzhou Medical University, Medical Engineering and Equipment Department,
Wenzhou 32500, Zhejiang, China

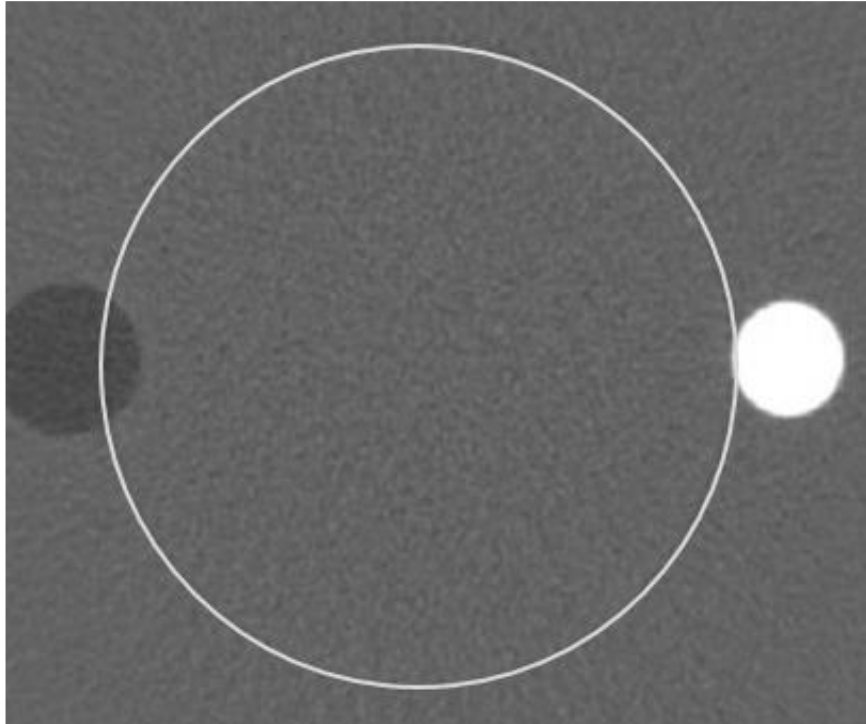
1) Artifact Phenomenon: As shown in the image below, straight line artifacts appear in the scanning positioning image, and thin single-ring artifacts appear in the transverse section. In the transverse section image, the image surrounding the ring artifacts shows no obvious anomalies, the artifact position is relatively fixed, and the ring density is uniform.

Troubleshooting: System error messages were reviewed, but no obvious issues were found. Air calibration was performed, but the problem persisted. Research indicated the artifacts were likely caused by a detector unit malfunction, a detector channel board malfunction, or dust or foreign objects on the detector surface. The equipment was cleaned and maintained to remove any foreign objects causing the artifacts. The faulty channel was located using the system's built-in data detection. The corresponding channel was moved to an edge position, and the equipment was calibrated and scanned again. If the artifact position corresponded to the channel adjustment, the channel was confirmed to be damaged. Software settings could be used to temporarily disable the faulty channel and ensure short-term departmental use. If the artifact position did not change after channel replacement, a detector unit malfunction was suspected and replacement was necessary.

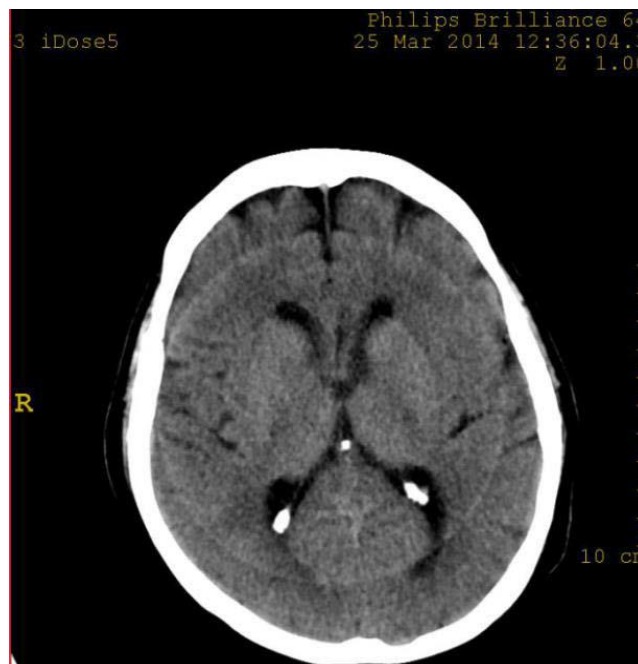
Figure 1

2) Artifact phenomenon: As shown in Figure 1, a faint ring artifact appears during scanning. Air calibration can eliminate it, but it will reappear after a short period of operation.

Troubleshooting: Common artifacts can be eliminated through phantom calibration and air calibration. However, this problem recurred shortly after being resolved. The artifact images showed largely consistent shapes and positions, and image processing revealed the problem persisted. Therefore, a hardware system fault was suspected. The maintenance interface indicated that the detector temperature was too high. Upon disassembly and inspection of the detector, it was found that one of the cooling fans (Figure 2) was blowing air outwards instead of drawing in air for cooling. Replacing the fan resolved the problem.
